Occupational Health & Safety Practitioner

CASE STUDY: HYDROFLUORIC ACID

January 2006

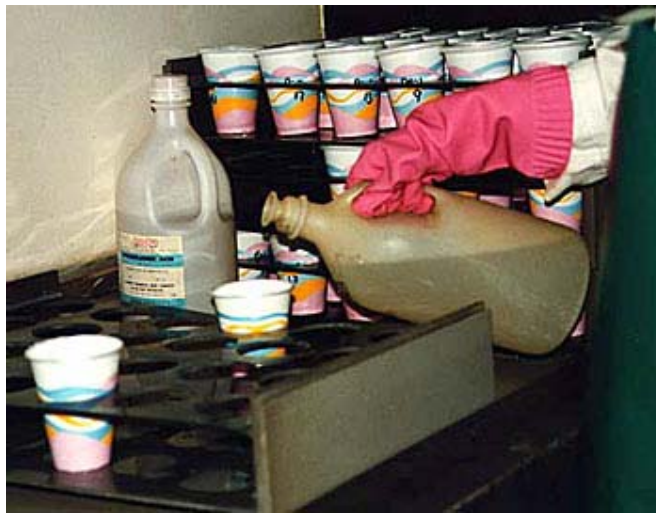
Above: The laboratory personnel may have minimised the likelihood of a spill through the introduction of cup supports for the digestion cups.

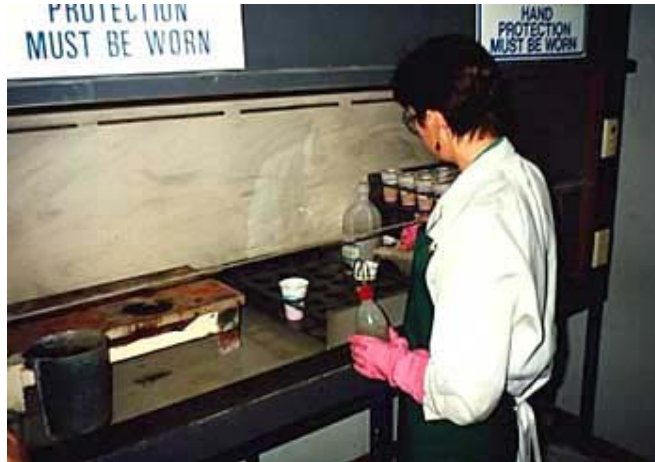
Above: Provision of a fume cupboard that had more working space, such as in this photograph, would have reduced the risk.
